Manhole Inspection Summary

Manhole # S21EE_031MH

Location Address: **1338 MOUNT ST**

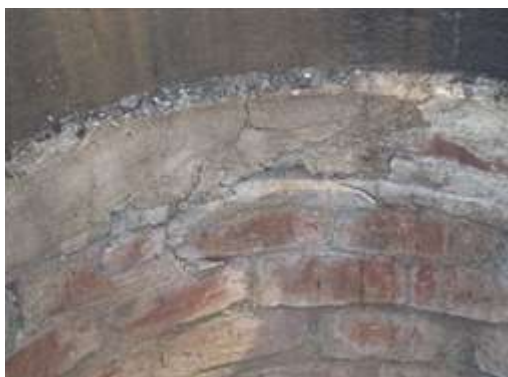
Defect 1

Condition: ☐ Sound ☒ **Cracked** ☐ Root Intrusion ☐ Loose Brick ☐ Deteriorated

CRACKED CHIMNEY

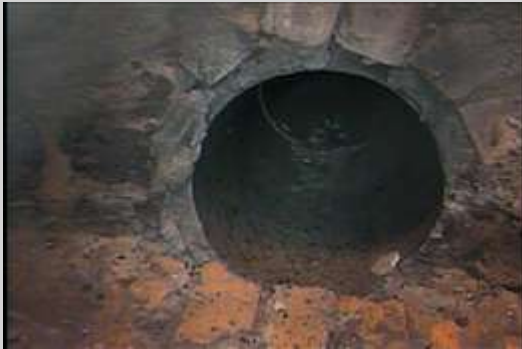
12 O'Clock Outflow

8 in. Circular Gravity Sewer
Pipe Out @ 12 O'Clock

Infiltration: **None** Pipe Seal Cond: **Sound**
